MISCELLANEOUS PAPER GL-85-21

CRATER REPAIR OF NORTH AUXILIARY AIRFIELD, SOUTH CAROLINA

August 1985

Final Report

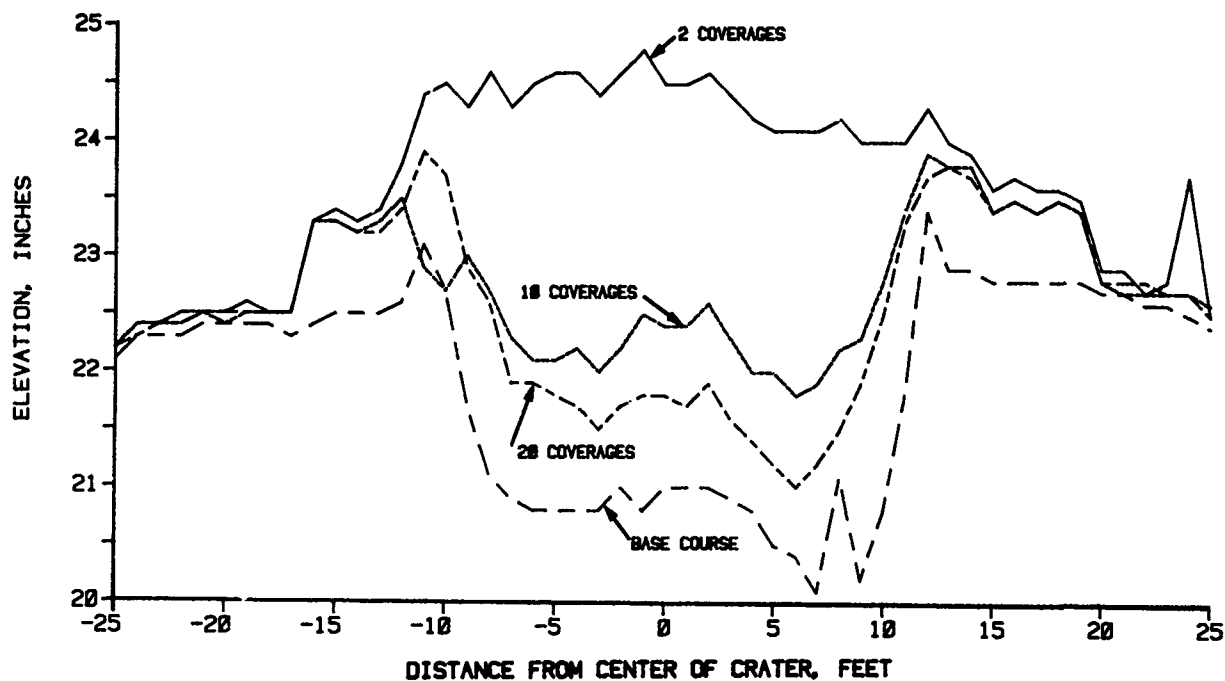
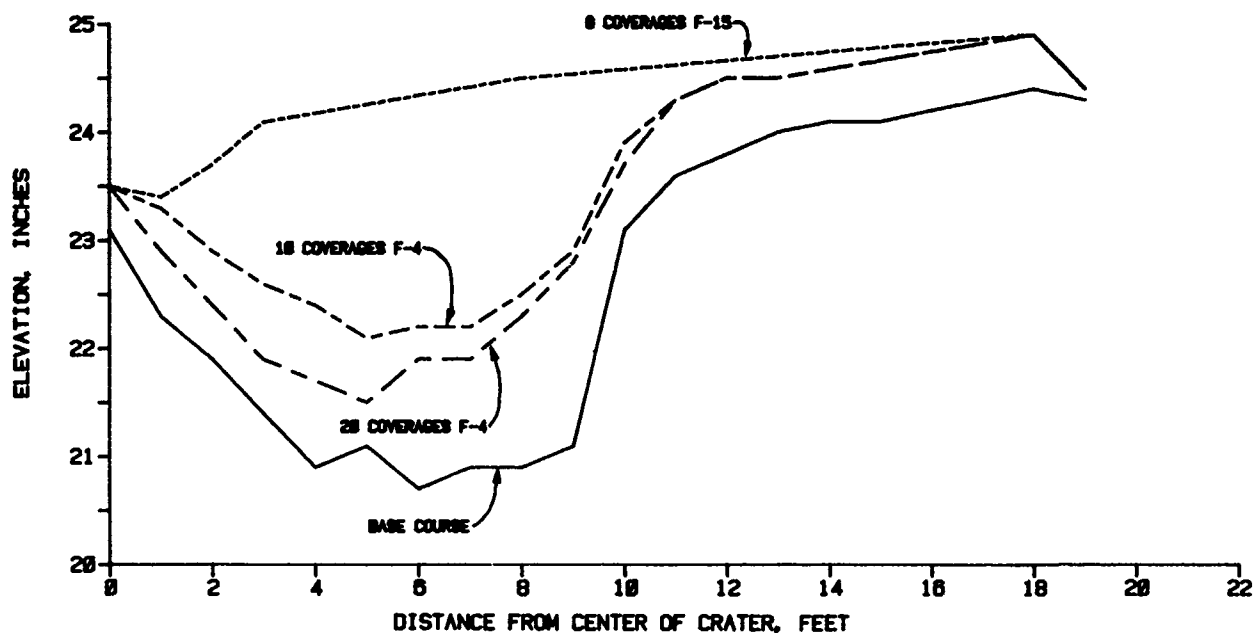
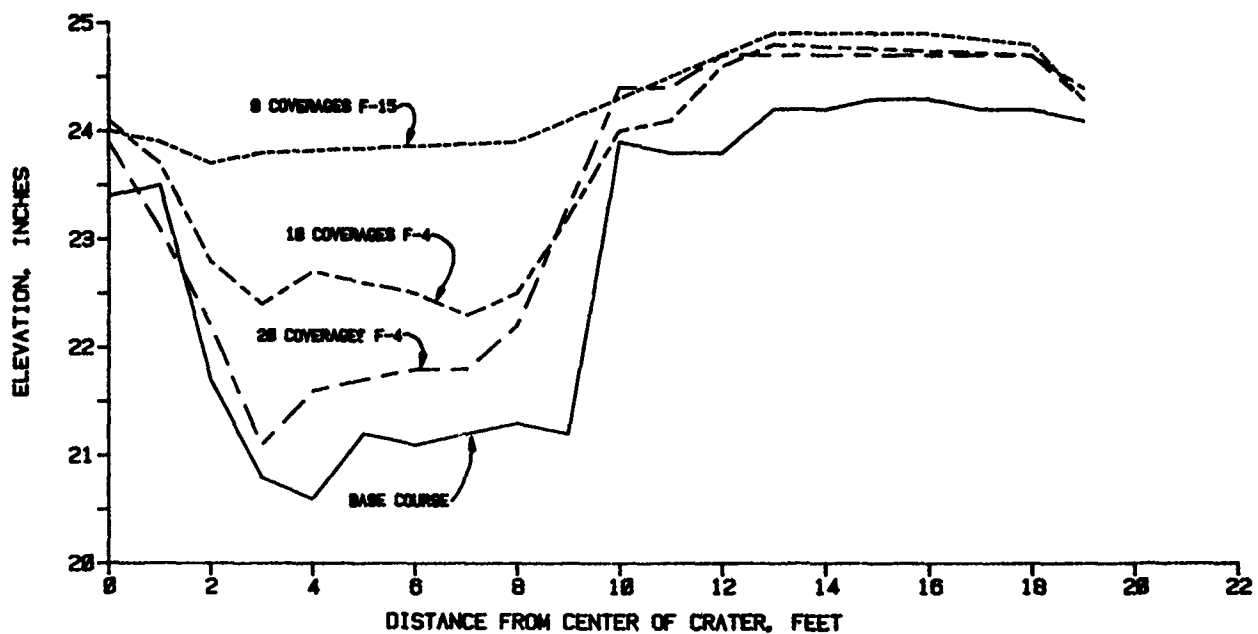
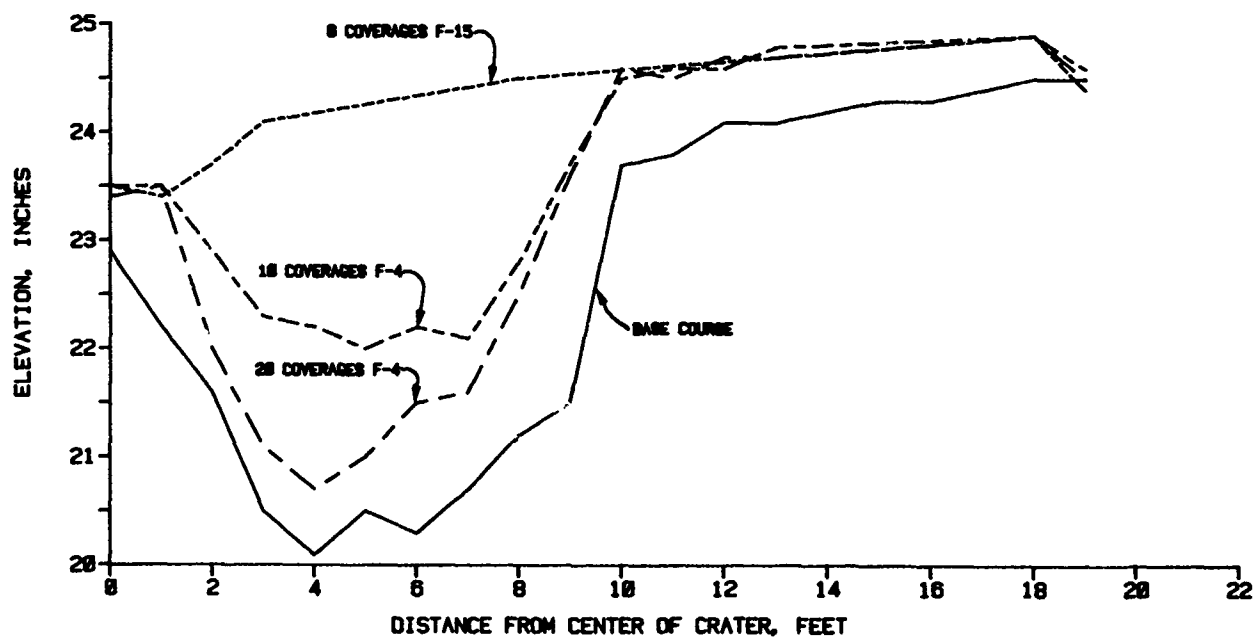
edge of this traffic lane. The two coverages of F-4 load cart traffic that were placed on the crater repair during the proof testing are included in the following performance data. Photo 49 shows the general condition of the traffic lane after proof testing (2 coverages). It should be noted that due to the previous weather conditions and the poor condition (tears) of the FOD cover in the F-15 traffic lane rainwater was trapped between the FOD cover and base material. Before test traffic was begun in this lane a 0.5-in. sag was measured along the center line of the traffic lane (Table 6). Plots of the profile data recorded along the center line of the traffic lane after various traffic levels are shown in Figure 78 and plots of the cross-section measurements taken during traffic are shown in Figures 79 through 81. The measurements for the plot labeled "2 coverages" in Figure 78 were taken after proof loading and before actual test traffic was applied in the test lane. The plots labeled "6 coverages F-15" in the Figures 79 through 81 are results of measurements recorded across the entire FOD cover width and before actual load cart test traffic was applied in the F-4 traffic lane. The first distress in the FOD cover was observed after six coverages of traffic. This distress included three tears through both plies of fiberglass, one tear in the top ply of fiberglass along the hinge, and damage to a patched portion of the hinge. The tears ranged in length from 1.5 to 3.0 ft. Photo 50 shows two of these tears. The patch damage consisted of the pond between a 8- by 20-in. patch and the hinge becoming loose on the south half of the patch. The maximum sag measured after six coverages of traffic was 1.75 in. As traffic was continued, it was noticed that the fiberglass along the hinge began to spall. This spalling which could possibly be a minor FOD problem was observed between six and ten coverages of traffic. The largest spalled area at this time was approximately 3 by 10 in. Other distresses observed after 10 coverages included the 8- by 20-in. patch which was completely disengaged from the hinge and either additional tears or an increase in length of the tears which occurred after six coverages. Photo 51 shows the surface condition along the hinge after 10 coverages. At this time four tears in the FOD cover hinge totaled 8.9 ft in length and the length of four top ply tears not on the hinge ranged between 1 and 5 ft. The maximum sag measured in the center of the traffic lane and at the hinge after 10 coverages of traffic was 2.13 and 3.00 in., respectively. Plots of the profile and cross-section data taken after 10 coverages of F-4 traffic are shown in Figures 78 through 81. The sag

Figure 78. Profile, center of F-4 traffic lane, FOD cover repair, 2 coverages, 10 coverages, and 20 coverages

increased as traffic continued. After 16 coverages the sag along the center line of the traffic lane was 2.75 in. Traffic was discontinued after 20 coverages because of high sag measurements and the difficulty of the load cart traversing the test area. The maximum sag measured after 20 coverages along the center line of the traffic lane was 3.0 in. and 3.5 in. along the hinge. The maximum sag measurements recorded during all phases of traffic applied on the south side of the crater repair (F-4 traffic lane) are plotted and shown in Figure 82. Before traffic was stopped, the load cart's pull wheels tended to spin as the load wheel approached and tried to negotiate the transition between the crater and existing PCC pavement. The load cart also leaned from one side to the other as it negotiated this transition. Photo 52 shows a general view of the traffic lane after 20 coverages. After traffic the FOD cover hinge was inspected and found to be torn almost the entire length of the crater and minor spalling of the fiberglass was also observed along the tear. Photo 53 shows a close-up of the torn hinge and spalling. Figures 78 through 81 show profile and cross-section plots taken on the surface of the FOD cover and on the surface of the base material after

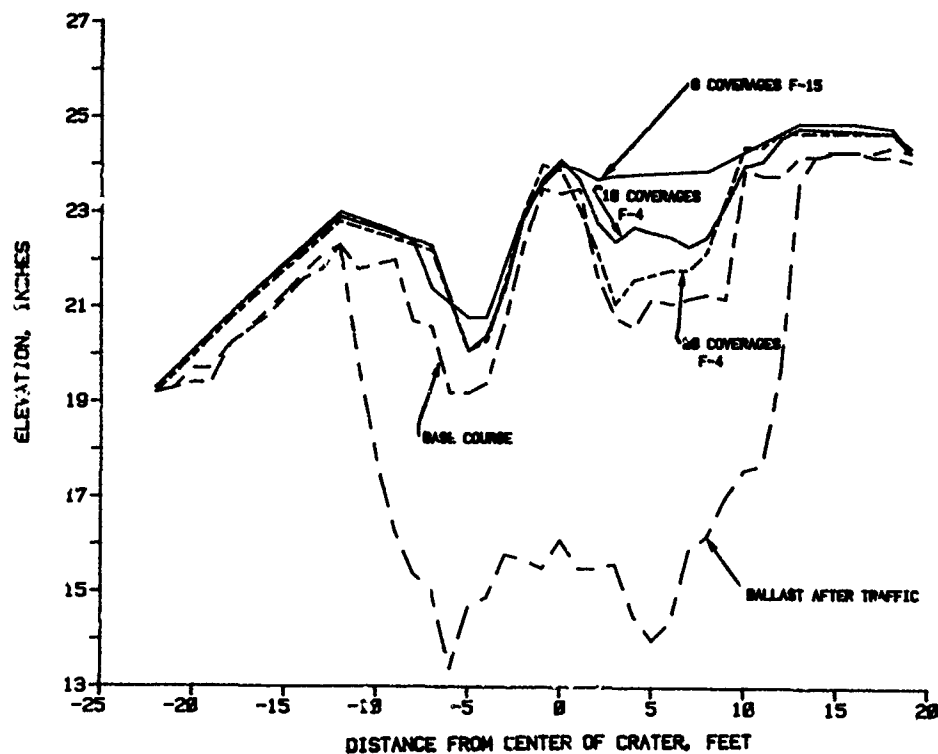
Figure 83. Center cross section, FOD cover repair after 6 coverages of F-15 traffic, 10 and 20 coverages of F-4 traffic

38. After the base course across the center of the crater was removed, cross-section data were recorded on the ballast. A plot of this data is shown in Figure 83.

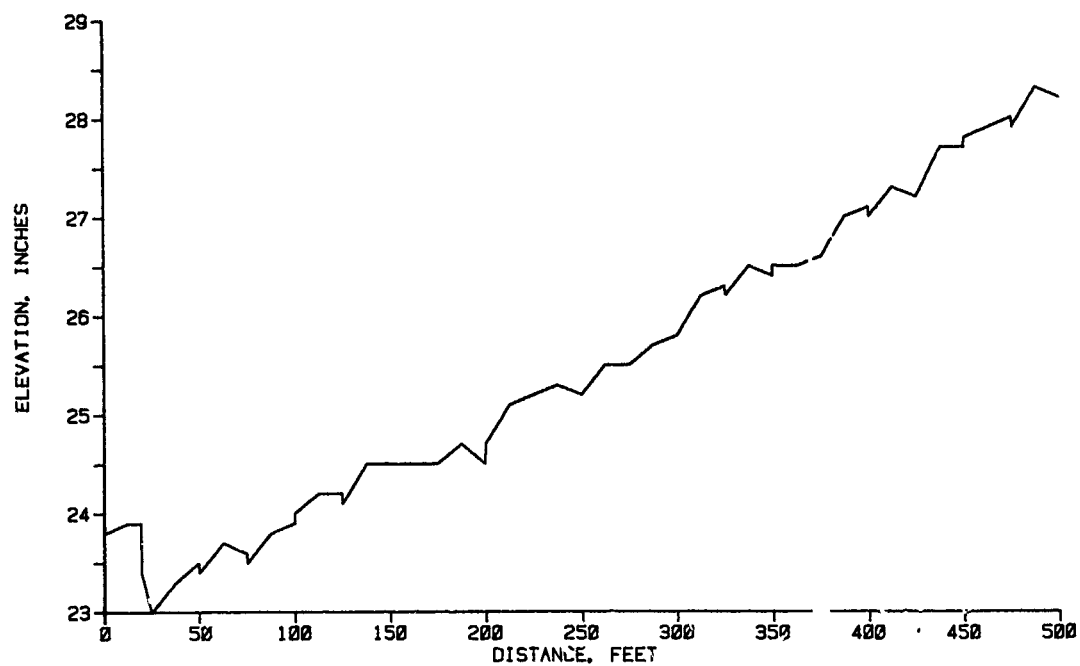
Figure 84. 500-ft lead-in profile, from the center of the crater east, south wheel path F-4 aircraft, FOD cover repair

40. Figure 84 shows profile data from the center of the crater repair out 500 ft east. The profile data were taken before any traffic was applied to the crater and were taken along the south wheel path of the F-4 aircraft.

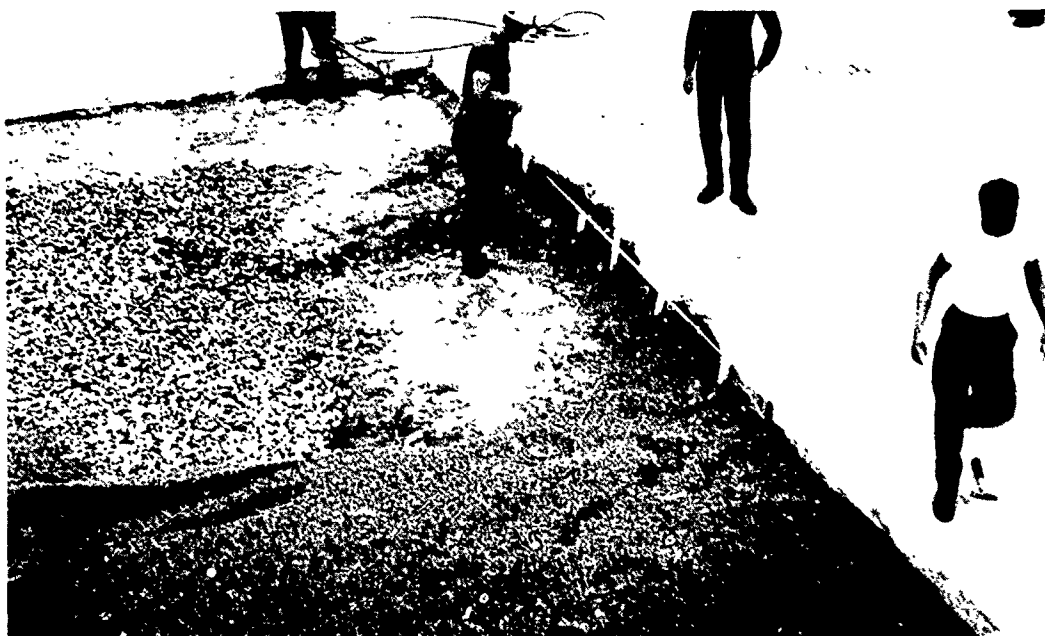
Photo 7. Precast slab repair with some of the leveling course in place and an area outside of the repair that requires patching with Silikal

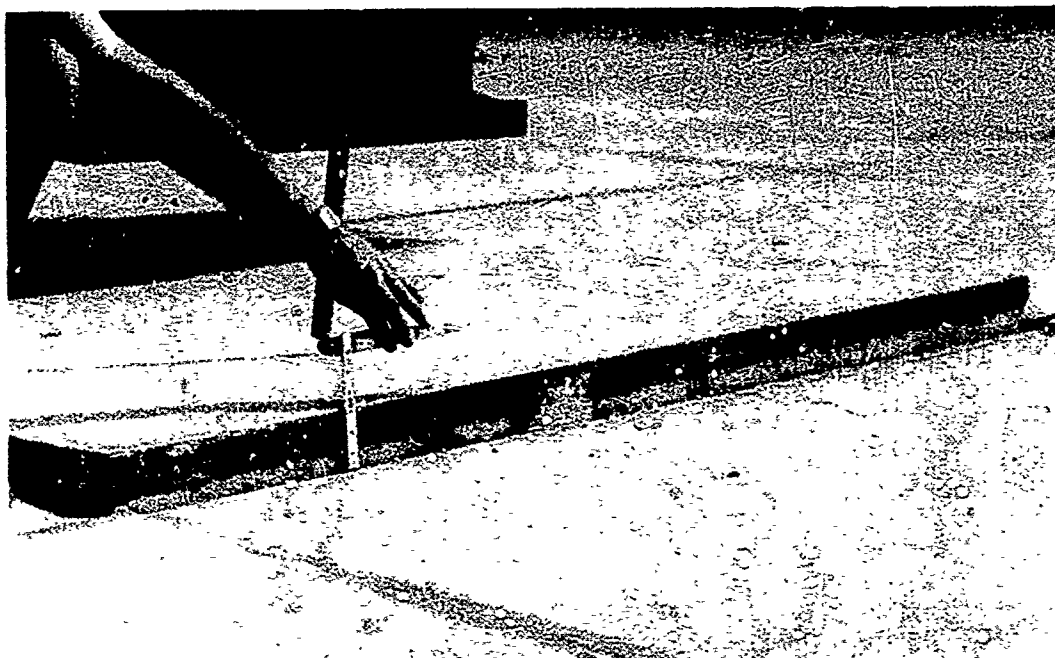
Photo 26. Slab movement after initial proof-testing,
precast slab repair

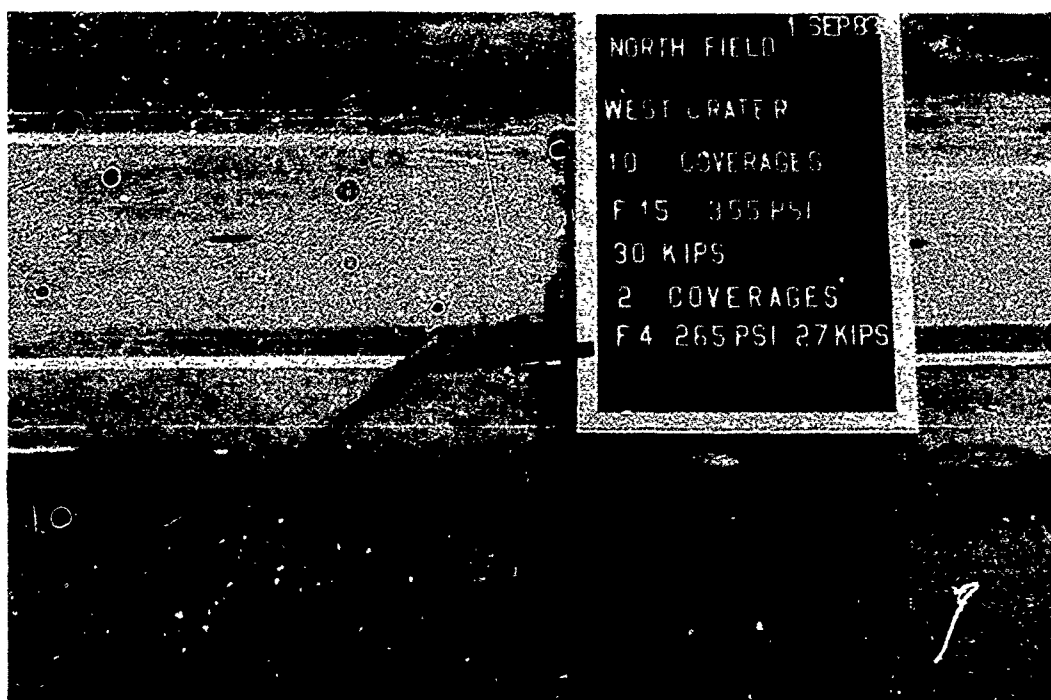
Photo 30. Spalling and sag measurement after 10 coverages of F-15, precast slab repair

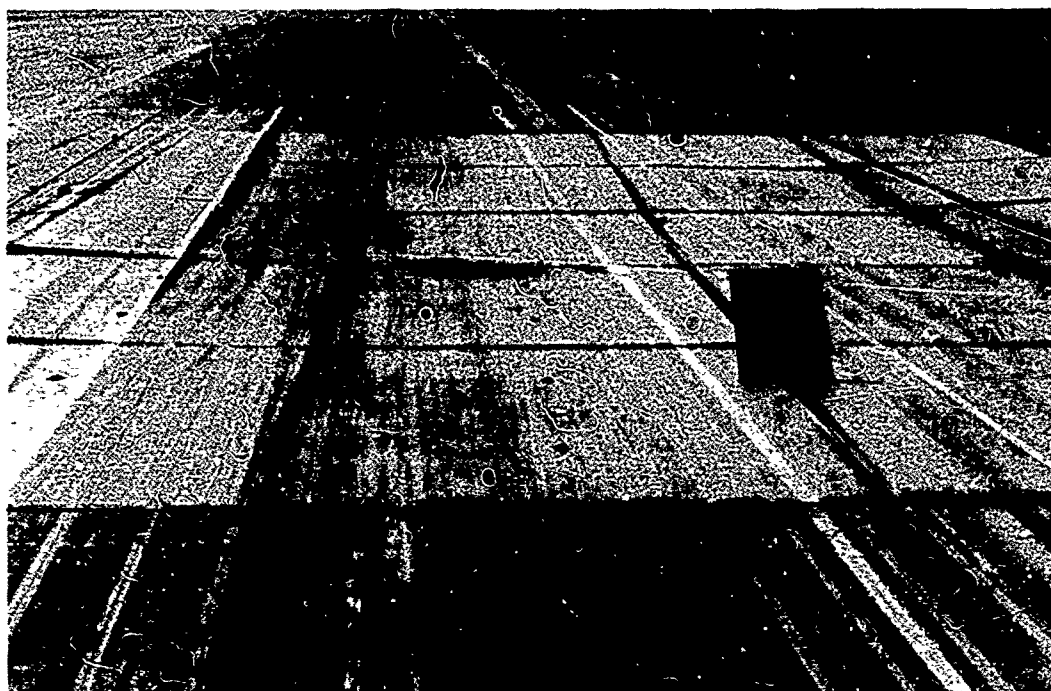
24 coverages, the sag measurement increased to 4.50 in. and remained 4.50 in. through 36 coverages (Table 4). Photo 38 shows the surface condition of the repair after 30 coverages; spalling is evident in this photo. Cracks were also evident in the 6-in. PCC original runway pavement at this time. Traffic was stopped after 50 coverages when the sag measurement was 5.00 in. The maximum sag measurements and the maximum joint difference (step) between the slabs recorded during all phases of traffic applied on the south side of the crater repair (F-4 traffic lane) and plotted are shown in Figure 48. Photo 39 is a general view of the traffic lane after 50 coverages. Spalled areas are visible on slabs 8 (note loose angle iron), 3, and 5 and there was spalling of

Photo 38. F-4 traffic lane after 30 coverages,
precast slab repair

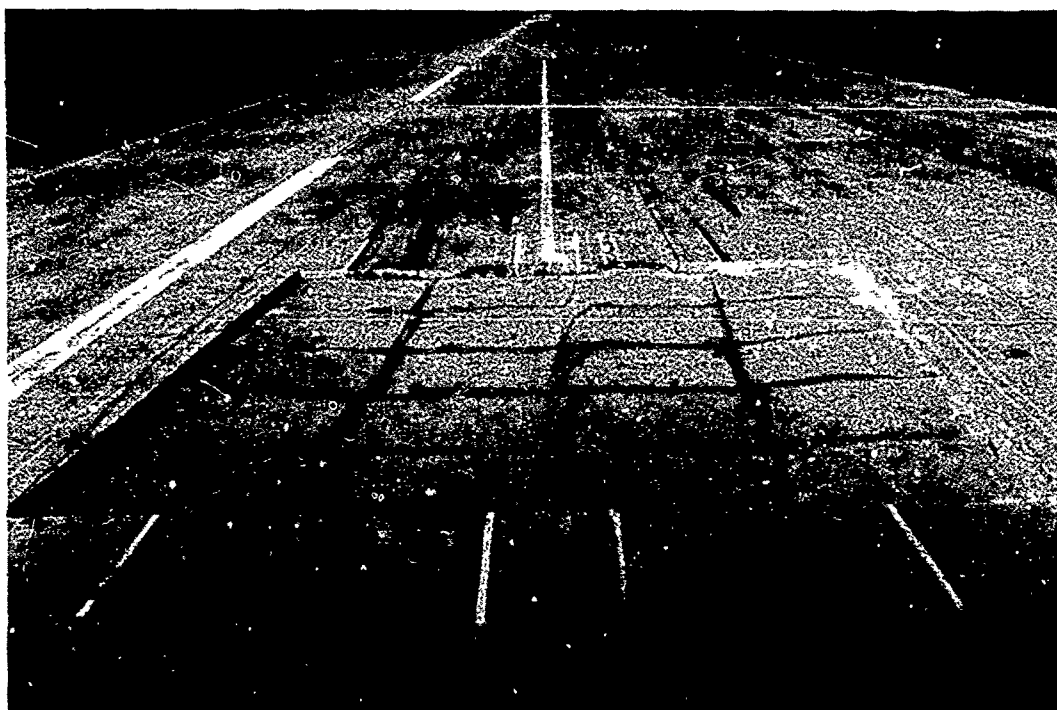
25. After traffic the slabs were removed using a military all-terrain forklift and chain hoist with the lifting keys attached. The slab removal was initiated in the northwest corner of the repair. The slabs were removed with a very minimum effort. Photo 40 shows the repair with the slabs removed. It is evident that there were voids between the slabs and leveling course because a live frog was found under the slabs when they were removed and the voids are reflected in the final profile data. Figures 50 through 61 show profile data giving comparisons of 0-coverage data (before any traffic), 50-coverage F-4 data (after all traffic had been applied), and the surface of the leveling course (slab removed).

Photo 40. Precast crater repair with slabs
removed after all traffic

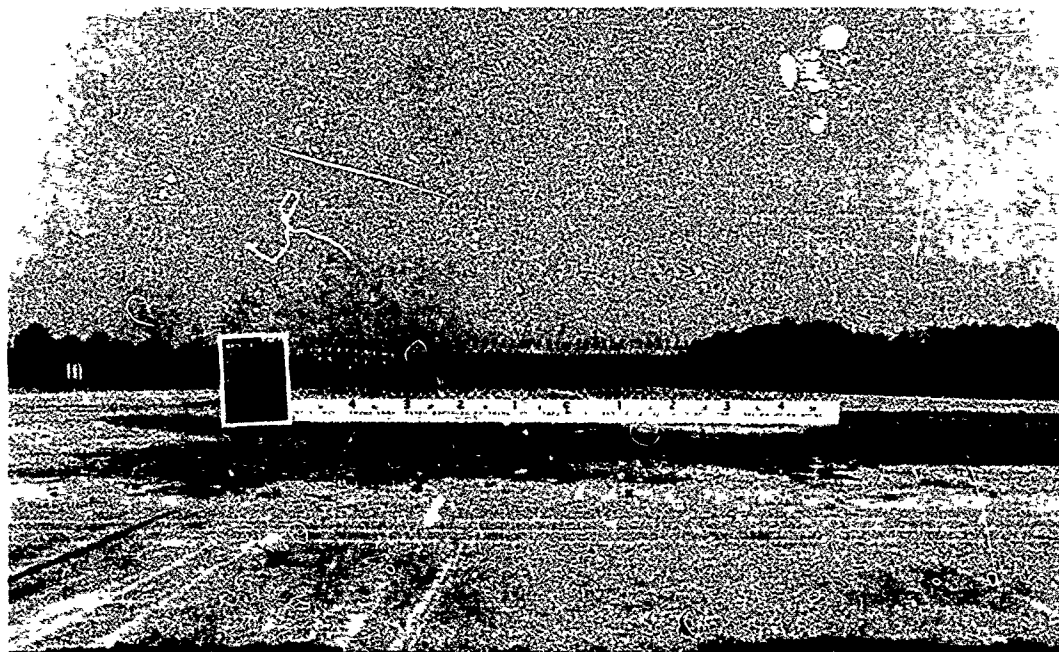
32. After aircraft traffic, the FOD cover was removed to obtain data on the base material and then the FOD cover was installed and load cart traffic begun. Photo 44 shows the rutting that had developed in the base course during proof loading and aircraft tests. Plots of the profile and cross-section measurements taken on the base course after aircraft traffic are shown in Figures 67 through 72. The average of five nuclear density tests performed on the base course after the aircraft traffic was 133.6 pcf (Table 2). Surface measurements taken during traffic and recorded in Table 6 indicate that a 1.5-in. maximum sag occurred in the south wheel (gear) path of the F-4 aircraft. Surface roughness measurements recorded after aircraft traffic and compared with those measured before traffic indicate a maximum consolidation of 4.5 in. (3.0-in. upheaval and 1.5-in. sag) had taken place in the wheel paths.

Photo 44. Rutting in the base course of the FOD cover repair

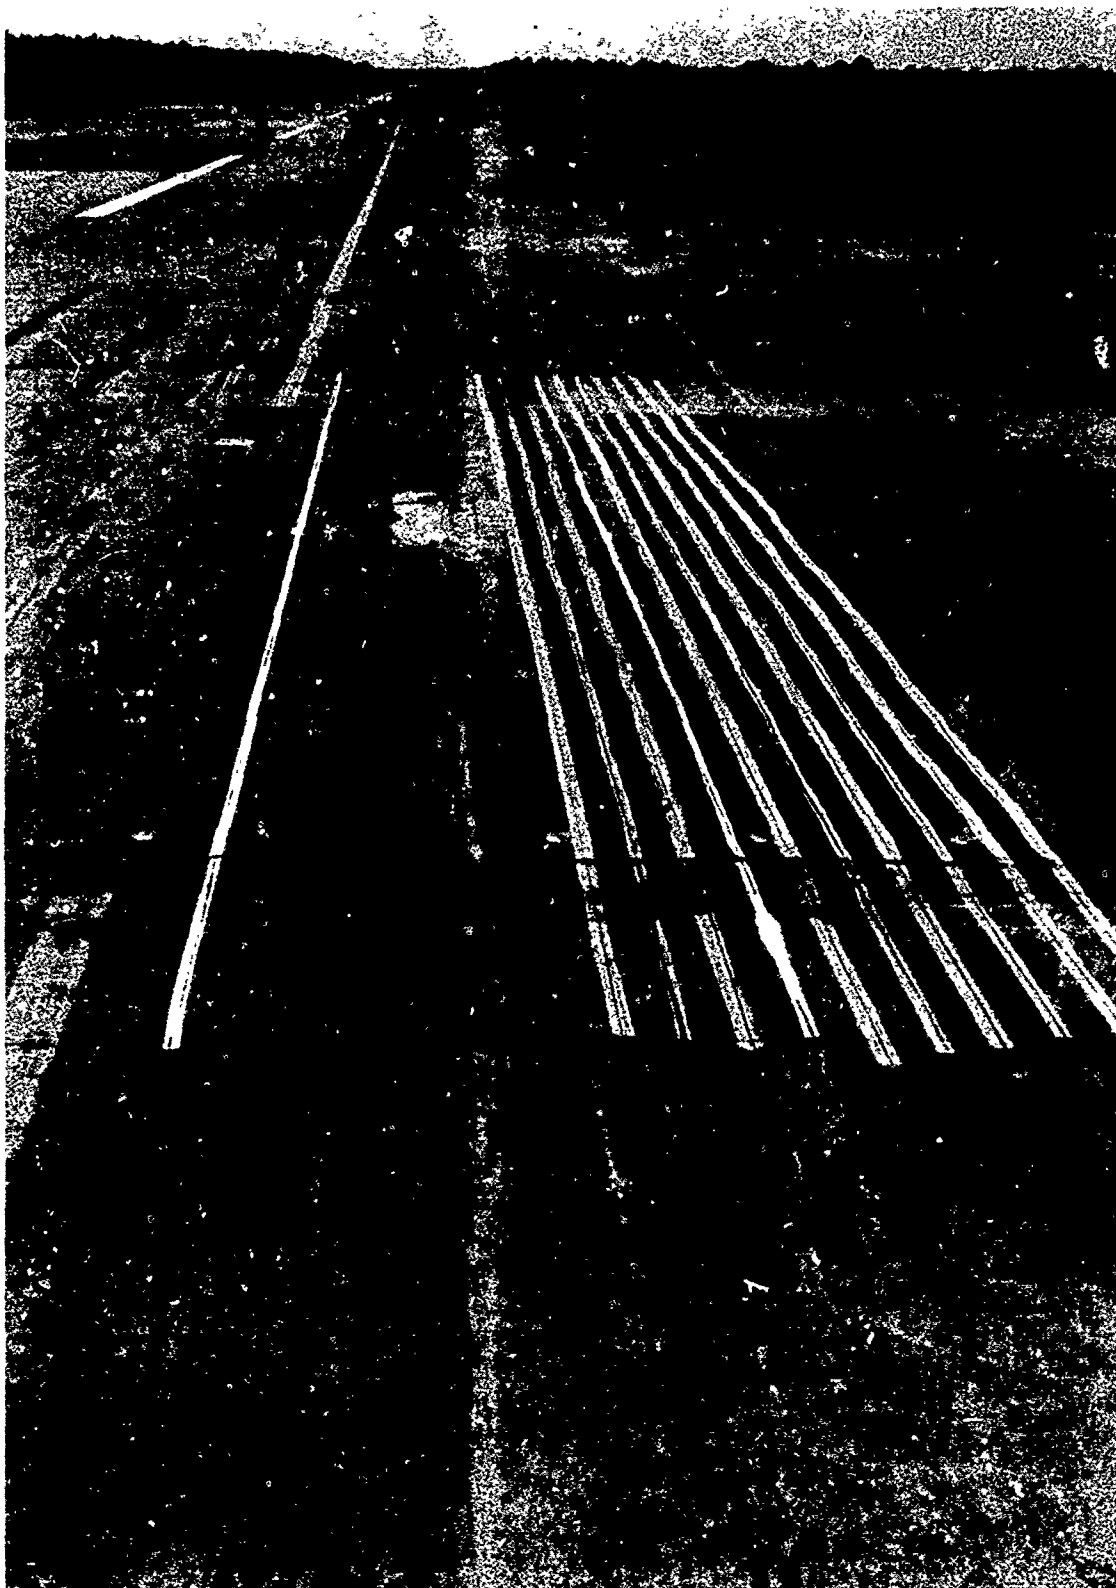
Photo 45. General view of the F-15 traffic lane after
2 coverages, FOD cover repair

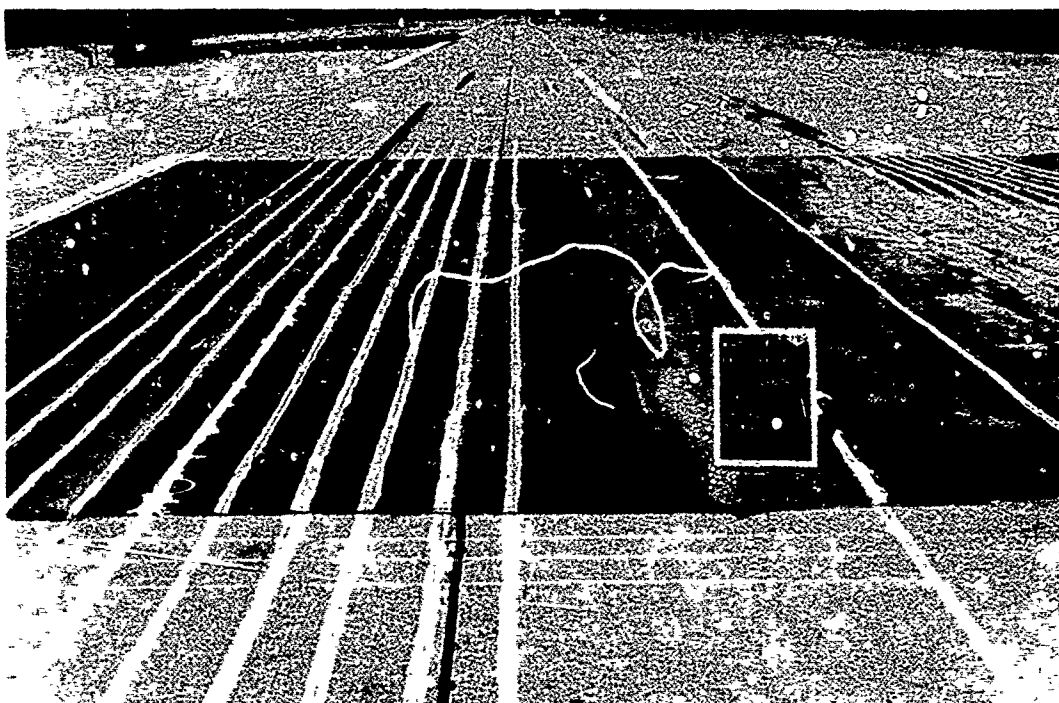
Photo 49. F-4 traffic lane before traffic was resumed,
FOD cover repair

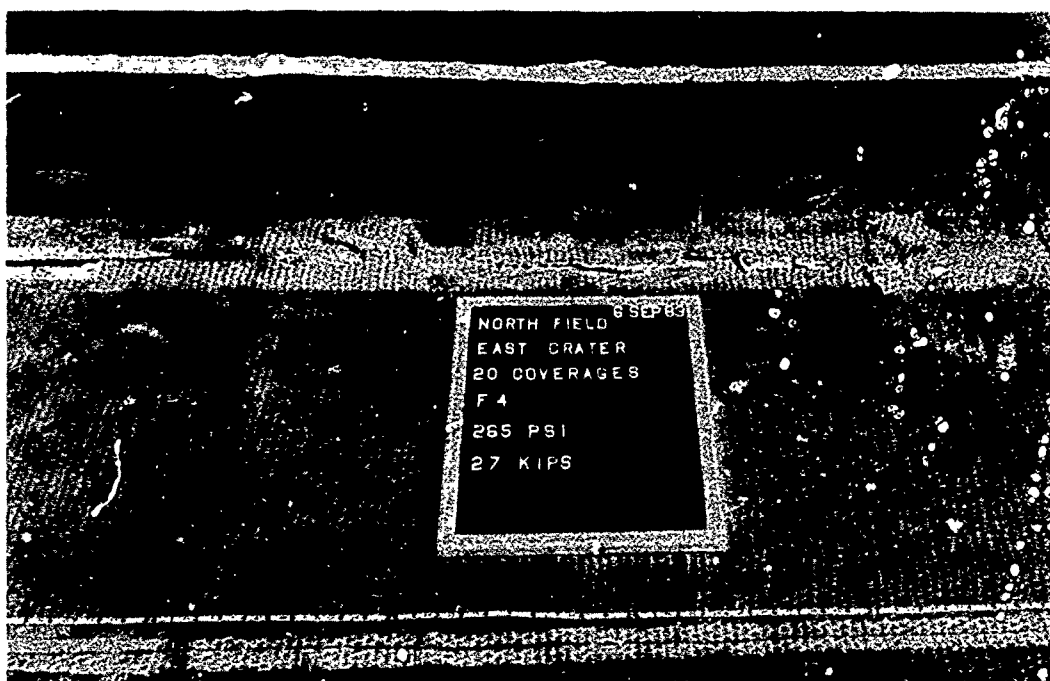
Photo 53. Close-up of spalling on torn hinge in the FOD cover repair after 20 coverages of F-4 traffic
